Contract No. CV/2007/03

**Development at Anderson Road –  
Site Formation and Associated  
Infrastructure Works**

**Quarterly EM&A Summary Report for  
March 2017 to May 2017**

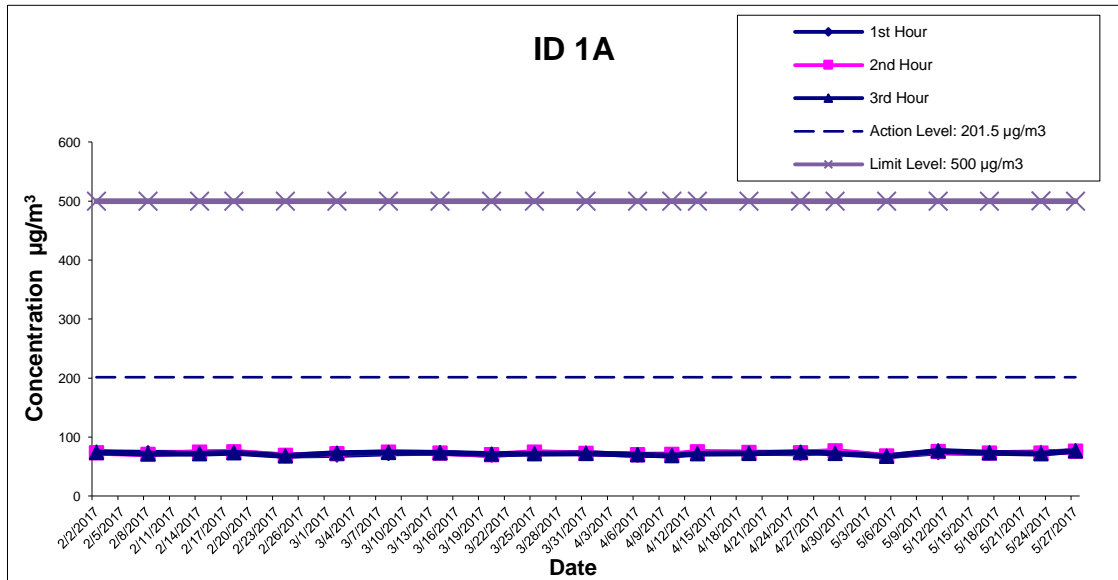
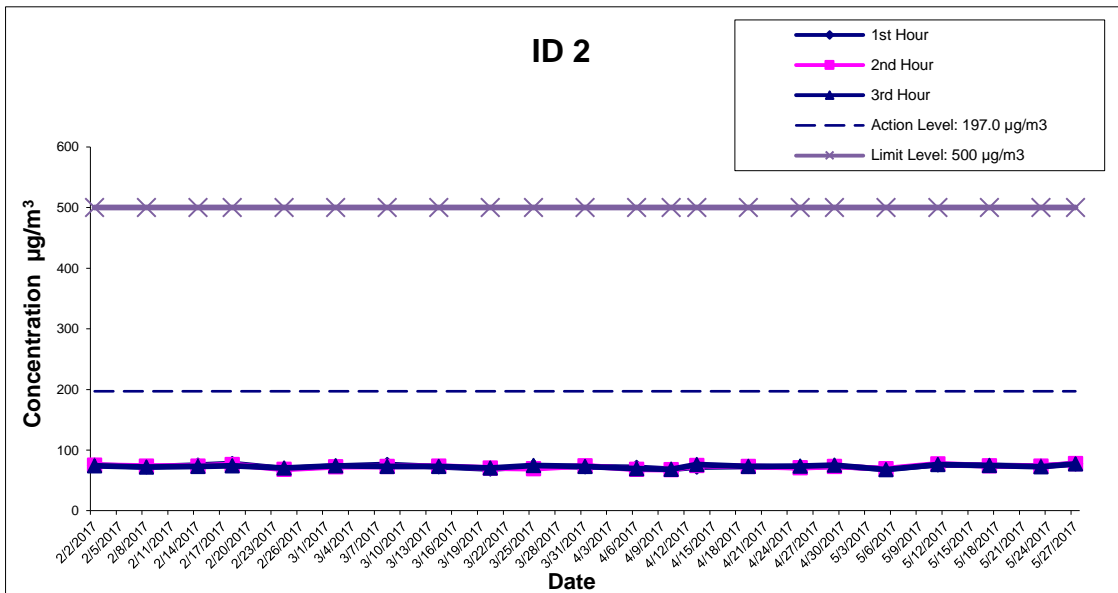
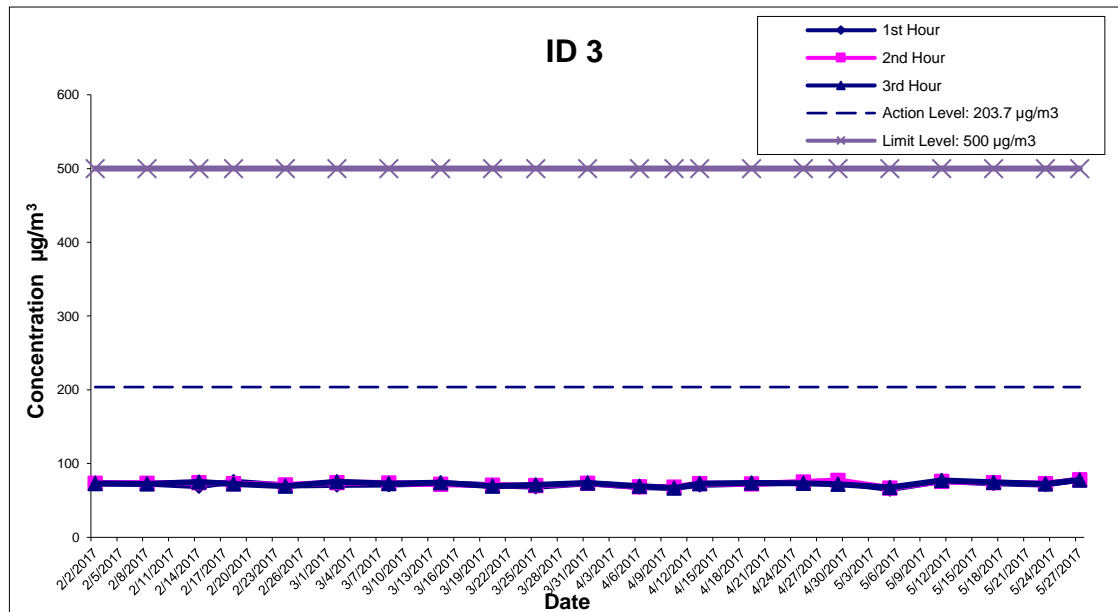
**Graphical Presentations of Impact 1-hour TSP  
Monitoring Results**

- 3.1.3 The weather was mostly fine, occasionally cloudy, sunny and rainy in the reporting quarter. The trend of impact air quality monitoring results for the reporting quarter is given in Appendix D. Major dust source included construction activities of the Project, concurrent construction activities of another project carried out in the vicinity and nearby traffic emissions.

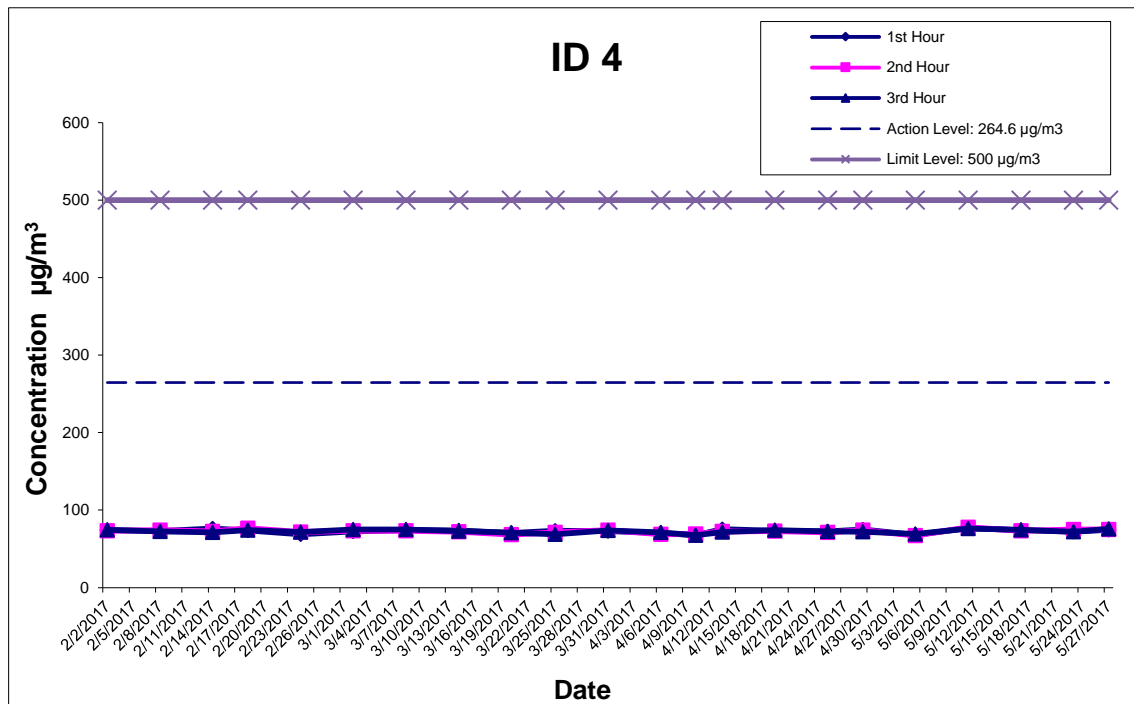
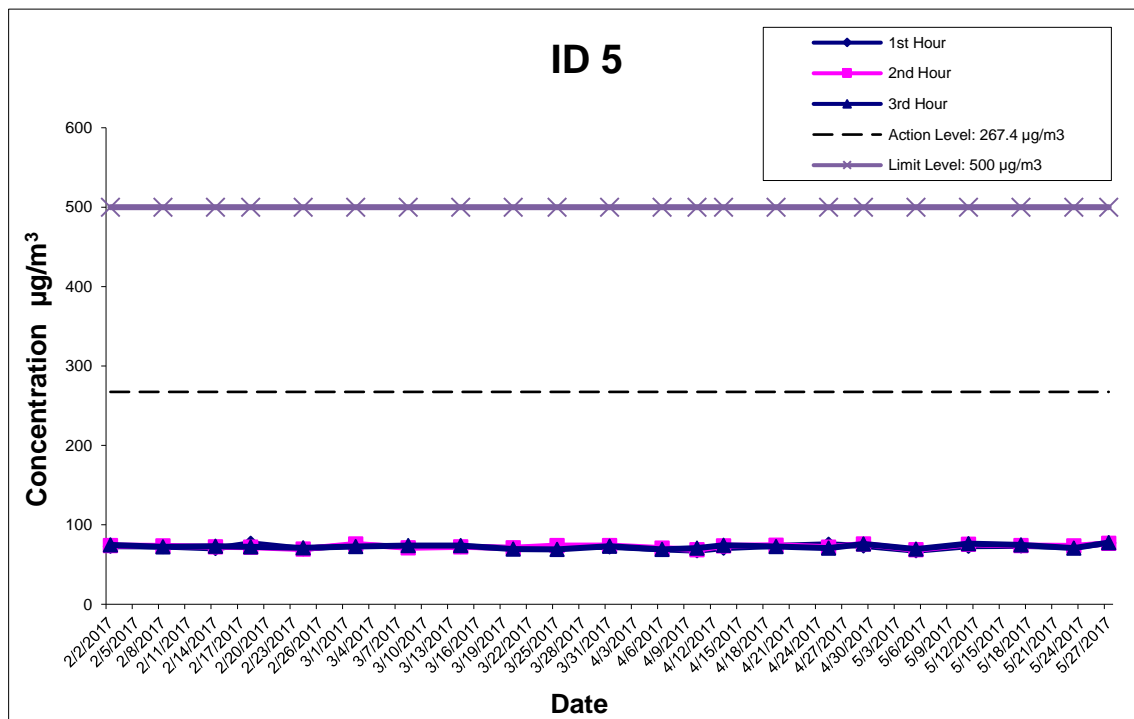
**Graphical Presentations of Impact 1-hour TSP  
Monitoring Results**

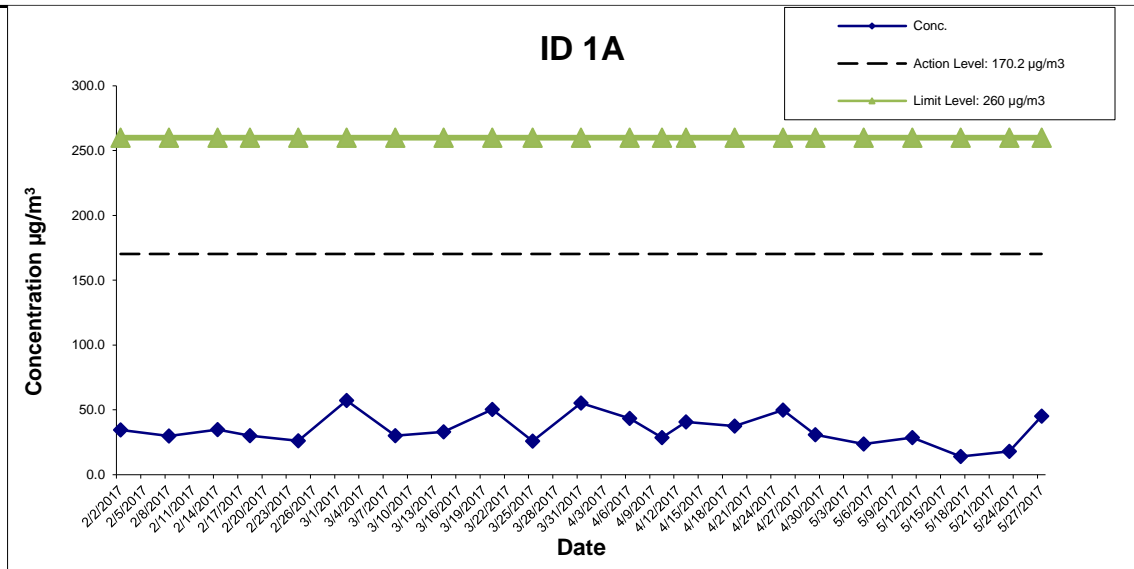
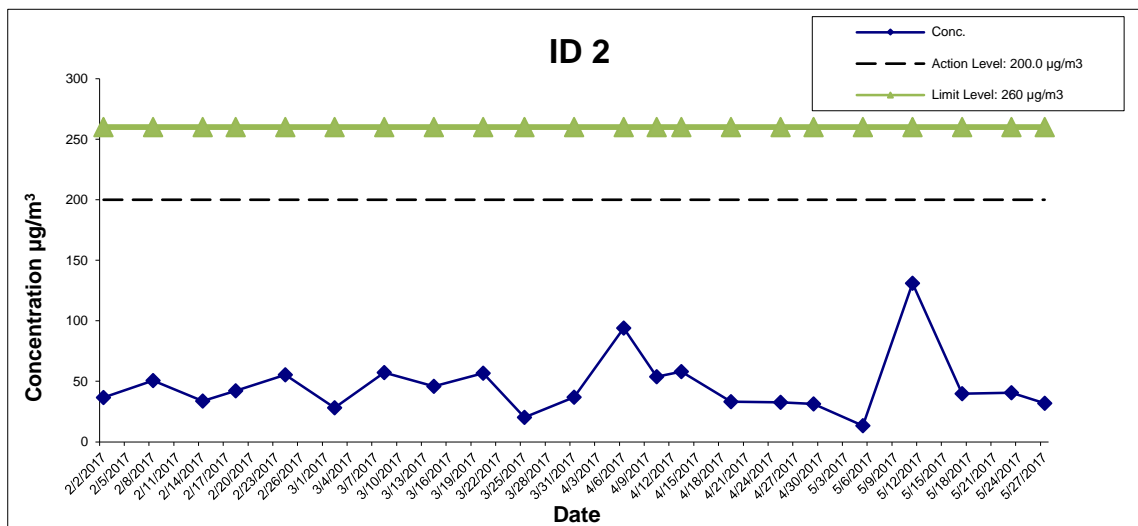
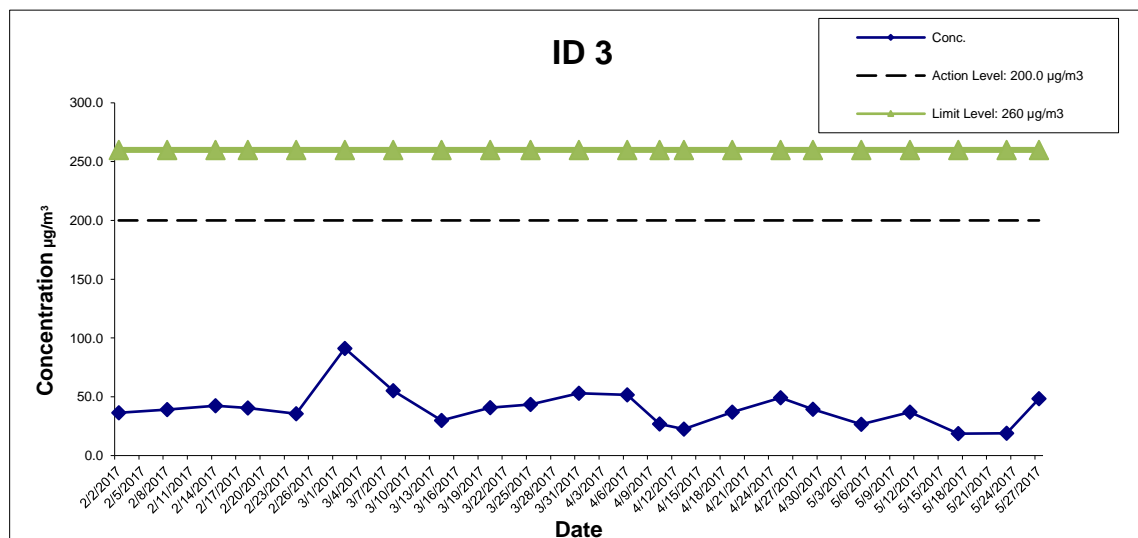
**Graphical Presentations of Impact 24-hour TSP  
Monitoring Results**

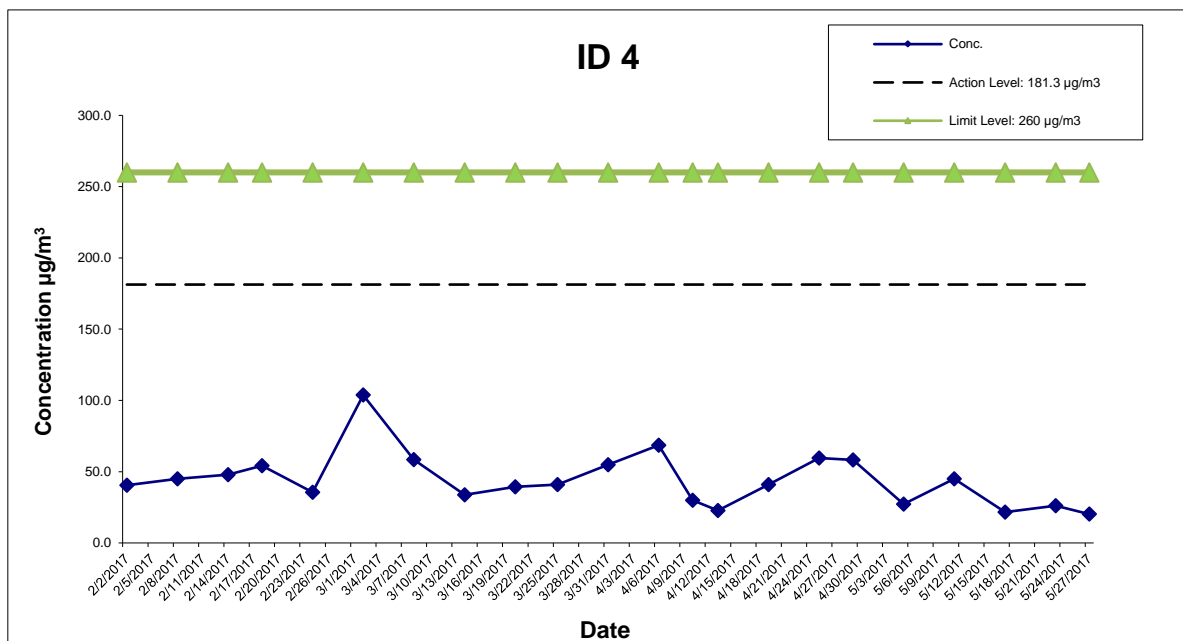
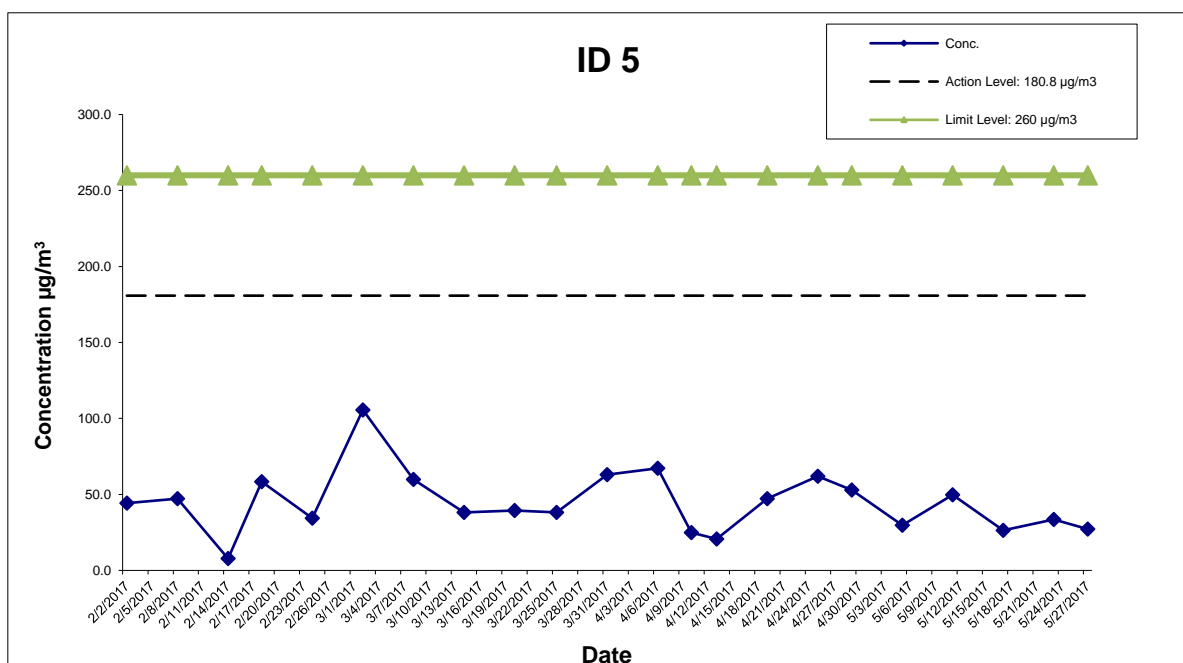
**Graphical Presentations of Impact 24-hour TSP  
Monitoring Results**

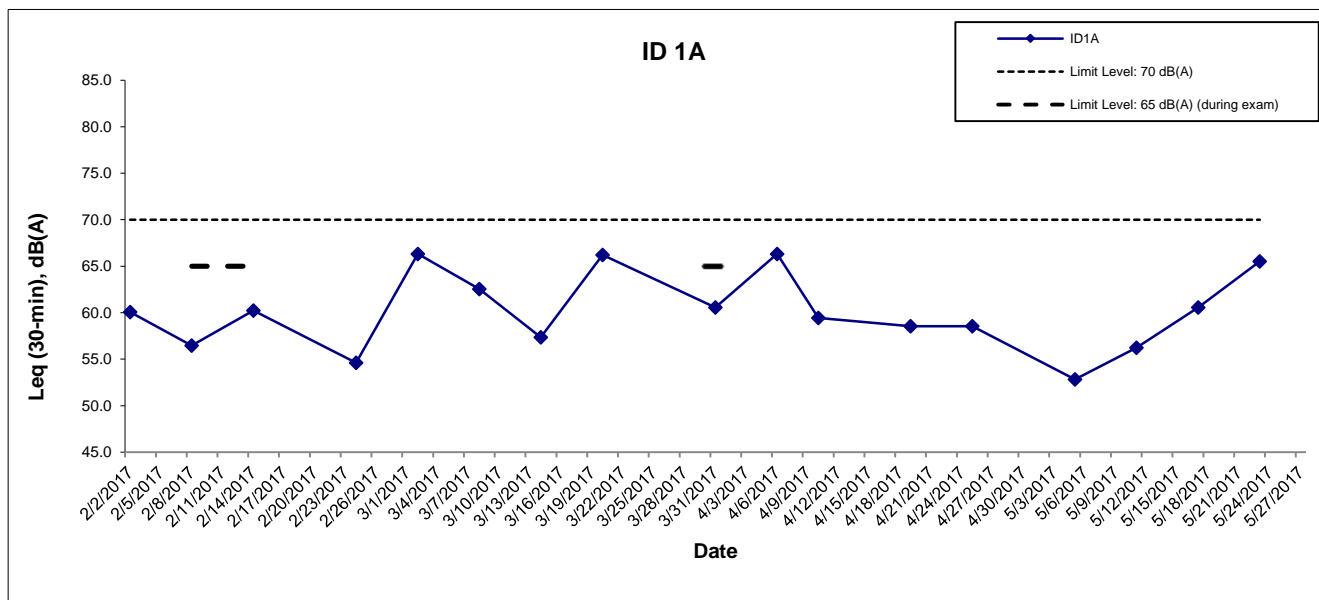
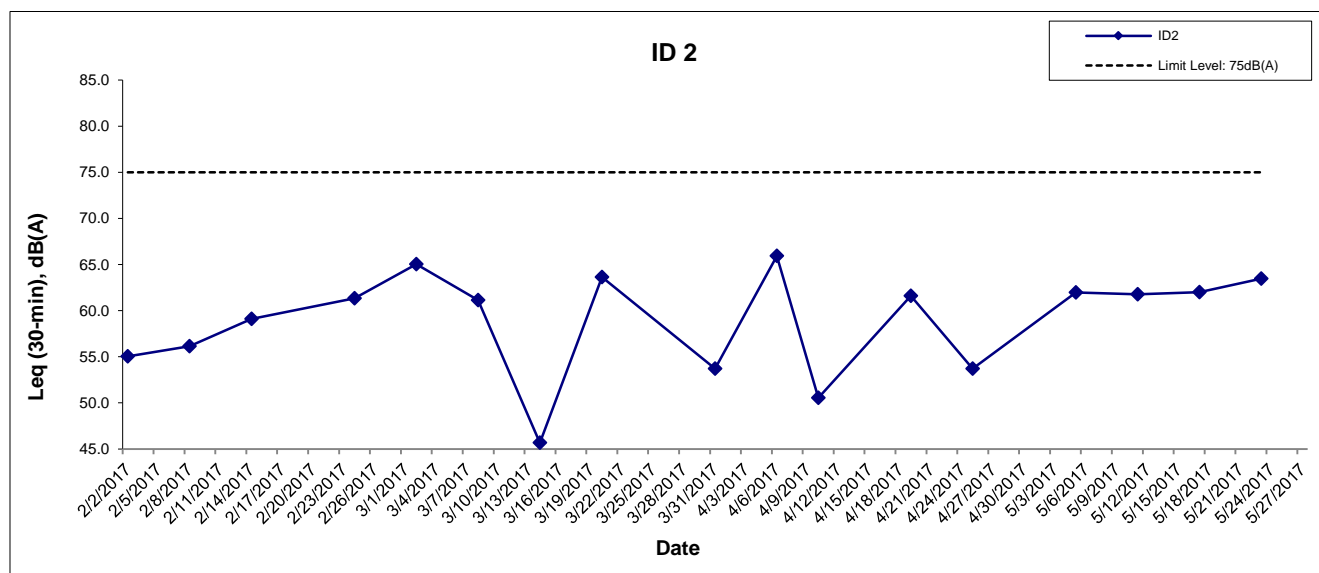
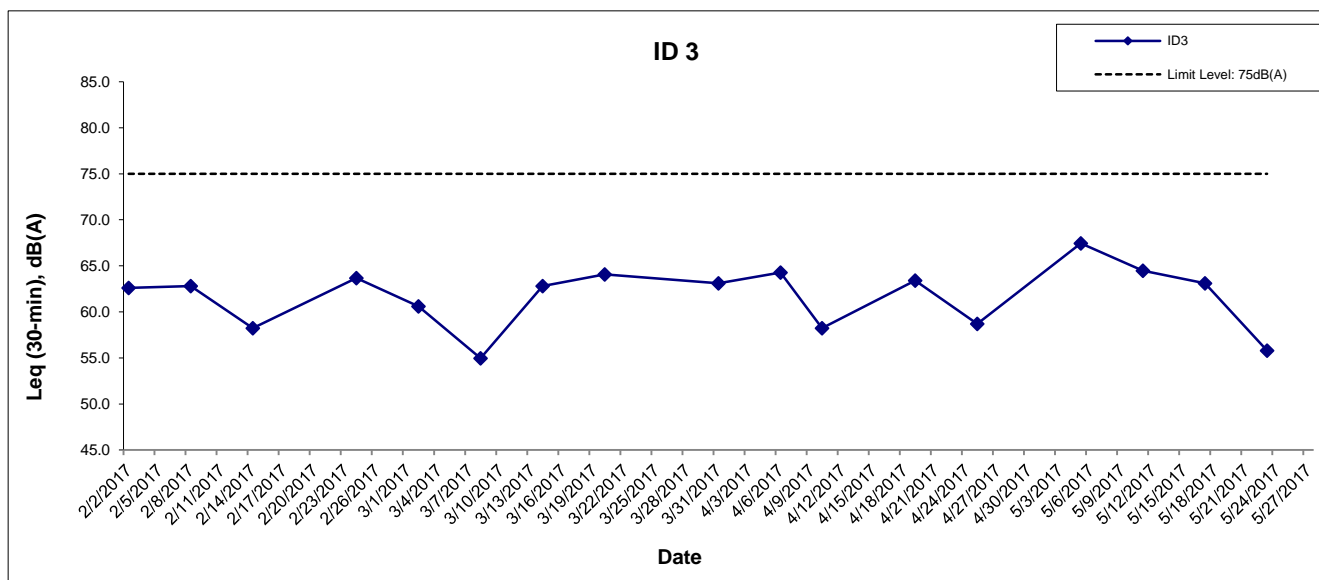
<b>Development at Anderson Road - Site Formation and Associated Infrastructure Works</b>  <b>Graphical Presentations of Noise Monitoring Results</b>	SCALE	N.T.S.	DATE	Jun-17
		CHECK	FYW	DRAWN	DTTW
		JOB NO.	60043155	APPENDIX E	Rev -

- 3.2.4 No Limit Level exceedance of noise was recorded in the reporting quarter.
- 3.2.5 The graphical plots of trends of the noise monitoring results in the reporting quarter are provided in Appendix E. Major noise source included construction activities of the Project, concurrent construction activities of another project carried out in the vicinity, nearby traffic emissions and noise from school activities and community noise.

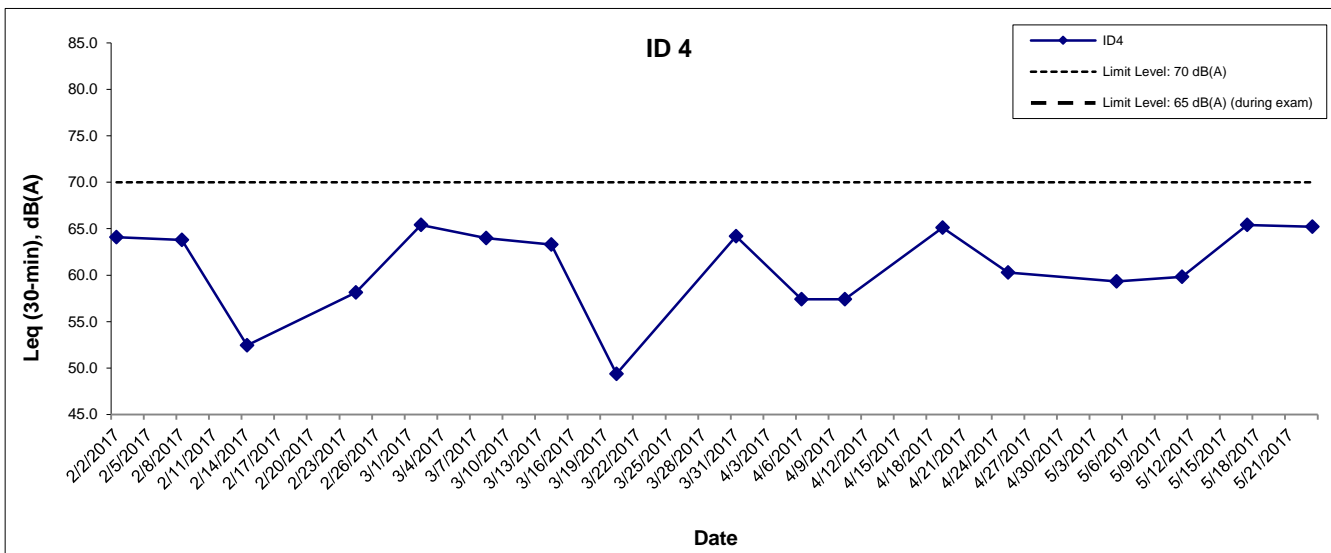
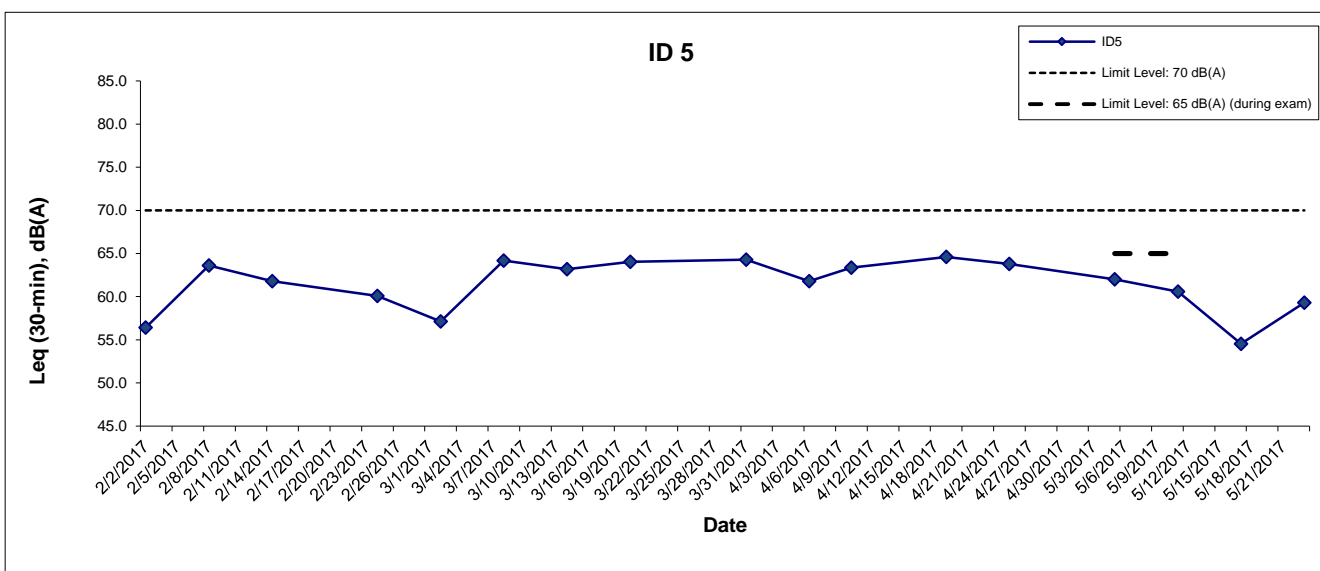
**Graphical Presentations of Noise Monitoring Results**
