Contract No. CV/2007/03

**Development at Anderson Road –  
Site Formation and Associated  
Infrastructure Works**

**Quarterly EM&A Summary Report for  
June 2017 to August 2017**

September 2017

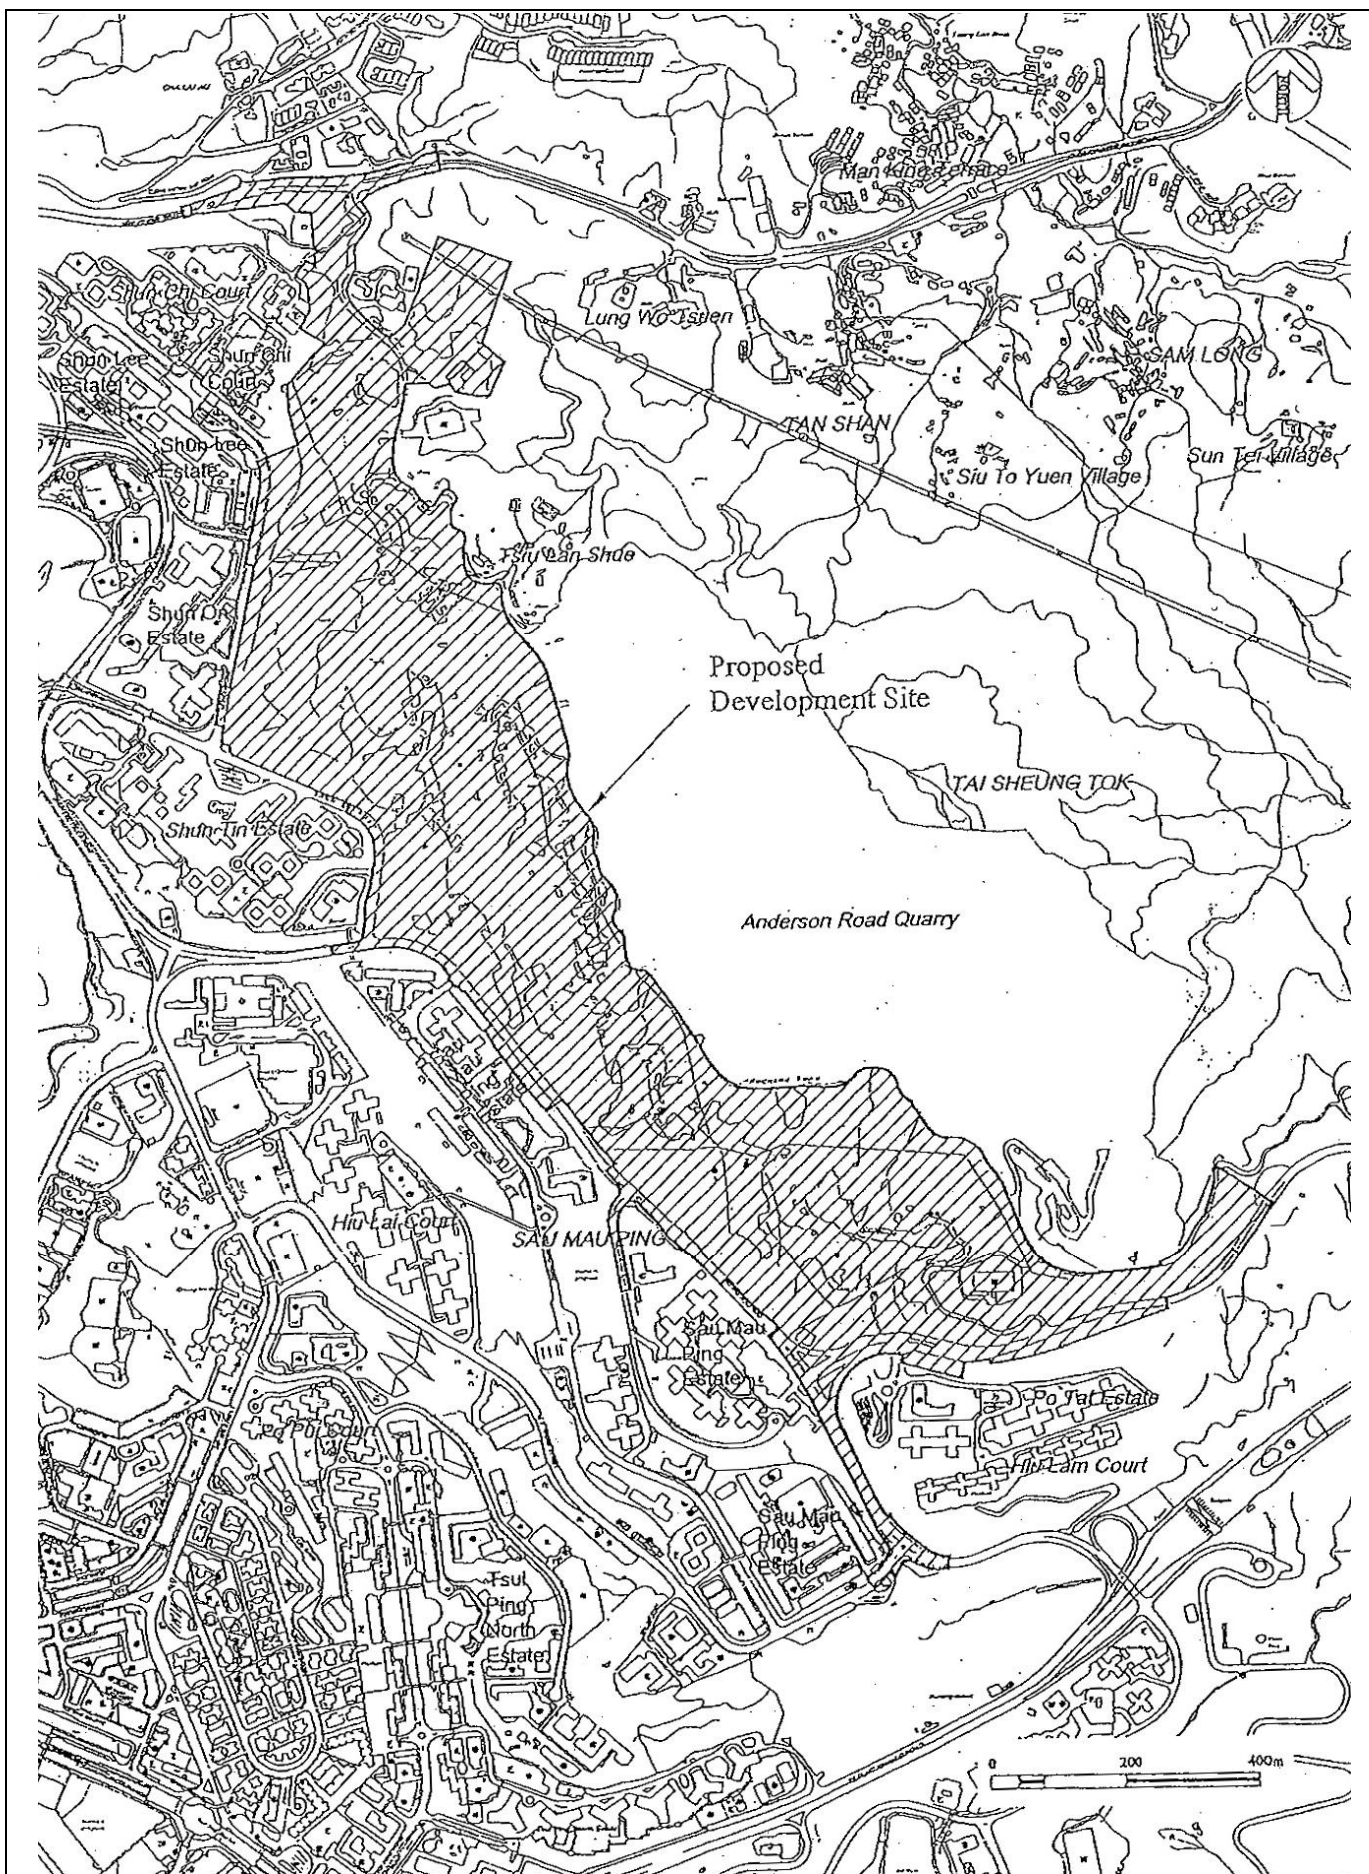
SCALE	N.T.S.	DATE	Nov-09
CHECK	ENFL	DRAWN	LCHC
JOB NO.	60043155	DRAWING No.	FIG 1.1
		Rev.	-

- 1.3.2 The general layout plan of the Project site showing the contract area is shown in Figure 1.1.
- 1.3.3 The environmental mitigation measures implementation schedule (EMIS) are presented in Appendix B.

GENERAL LAYOUT PLAN

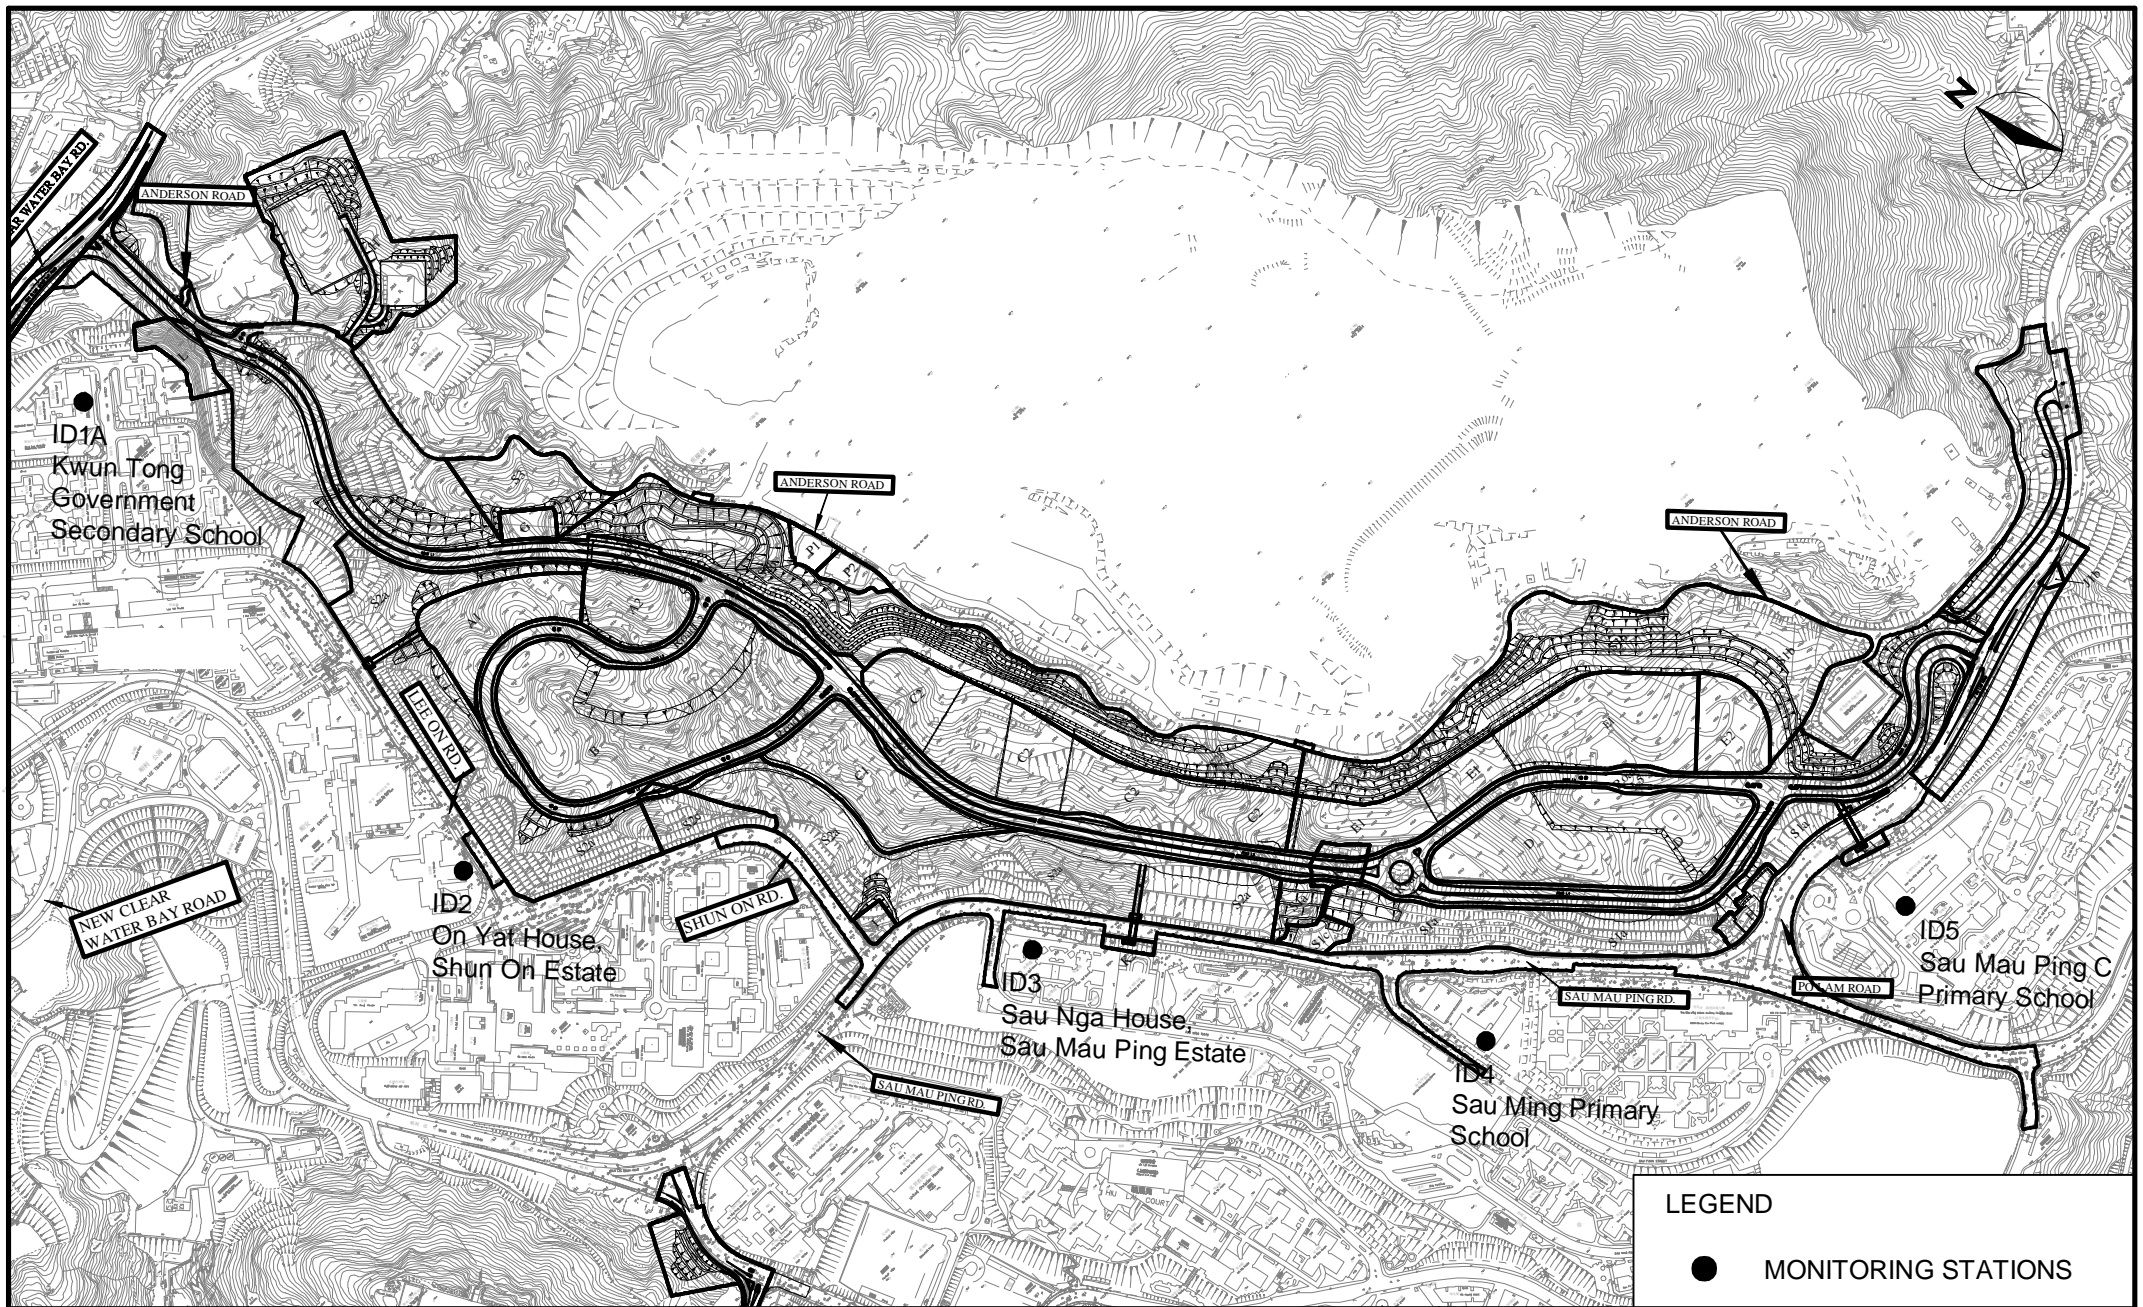
- 2.1.1 The EM&A Manual designated five monitoring stations to monitor environmental impacts on air quality and noise due to the Project. The monitoring locations are depicted in Figure 2.1.
- 2.1.2 The monitoring stations ID 4 & ID 5 will serve both the entire Development of Anderson Road (Schedule 3 Designated Project (DP)) project as well as the Widening of Po Lam Road (Schedule 2 DP) project.

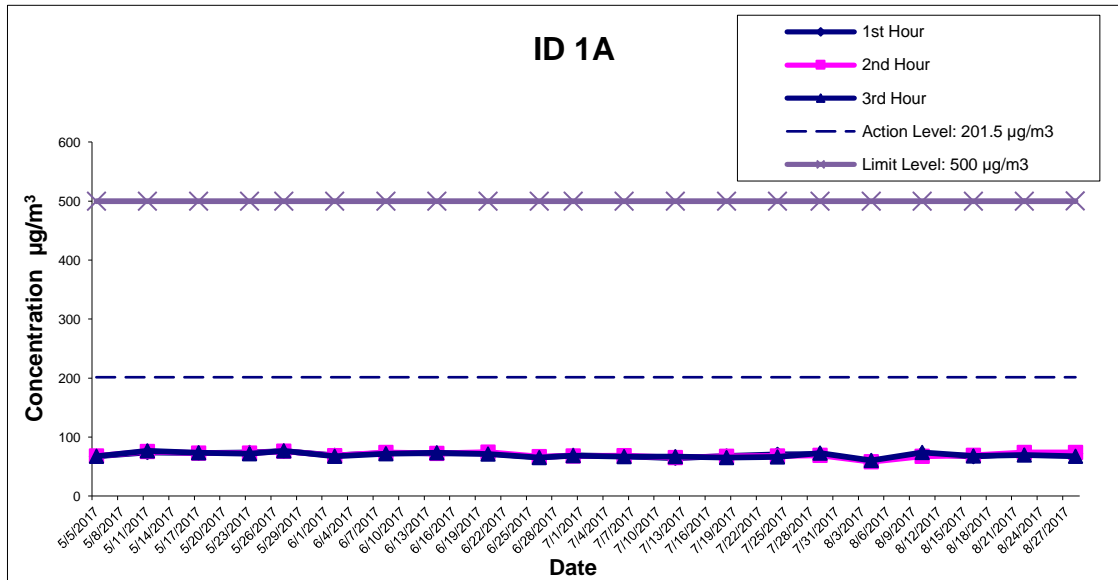
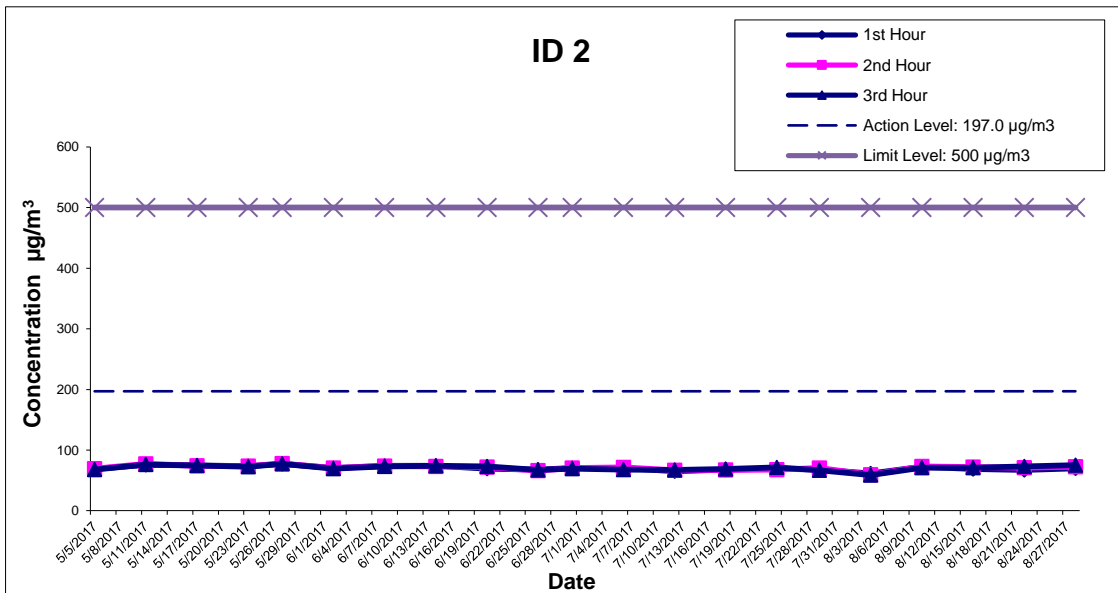
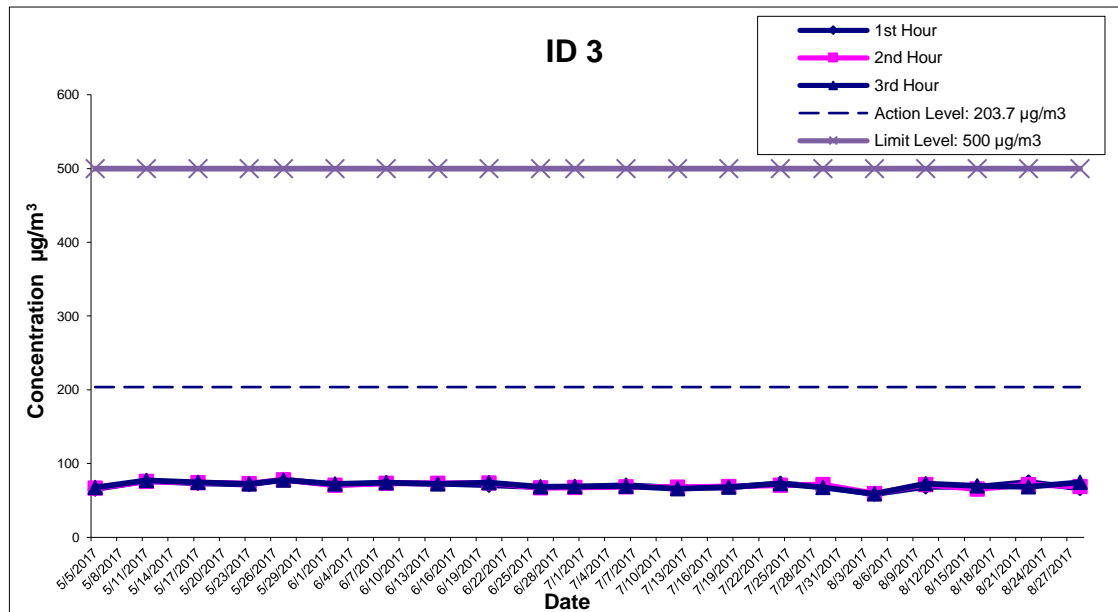
SCALE	N.T.S.	DATE	Sep-17
CHECK	FYW	DRAWN	CCWT
JOB NO.	60043155	APPENDIX No.	Rev.
		D	-

- 3.1.3 The weather was mostly sunny and cloudy, occasionally rainy and fine in the reporting quarter. The trend of impact air quality monitoring results for the reporting quarter is given in Appendix D. Major dust source included construction activities of the Project, concurrent construction activities of another project carried out in the vicinity and nearby traffic emissions.

- 3.1.4 All 1-hour TSP and 24-hour TSP results were below the Action and Limit Levels in the reporting period.
- 3.1.5 Table 3.1 presents the number of exceedances recorded in each month of the reporting quarter. The number of monitoring events included regular impact monitoring events and additional ones, if any.

**Graphical Presentations of Impact 1-hour TSP  
Monitoring Results**

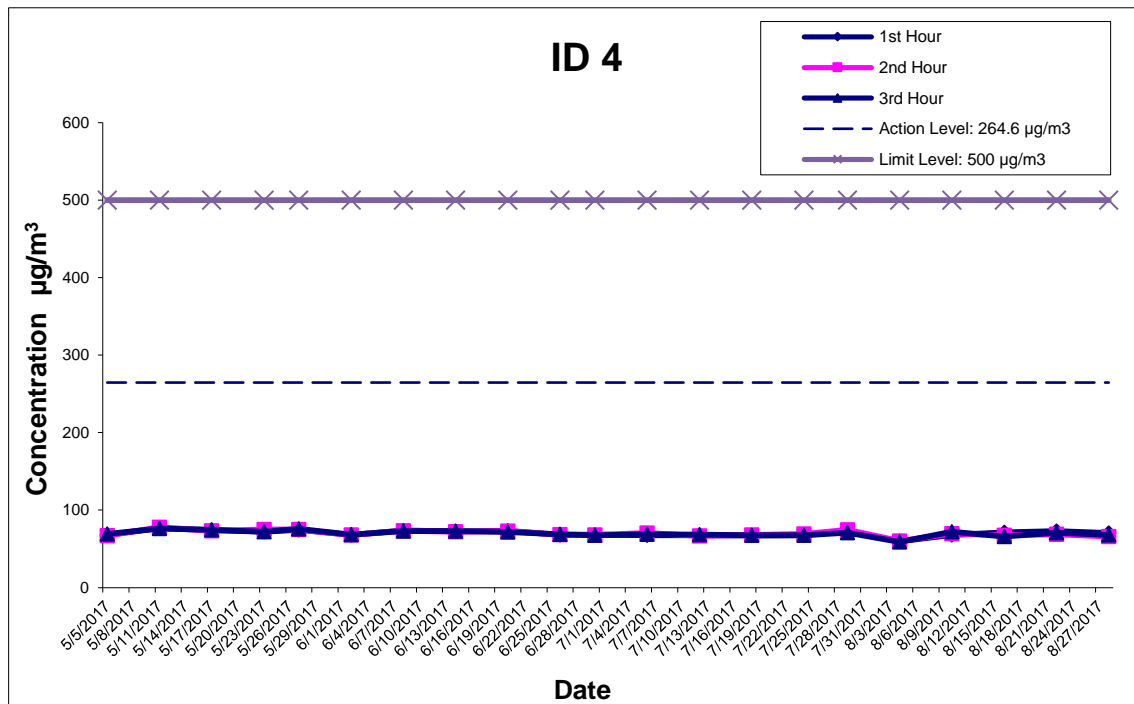
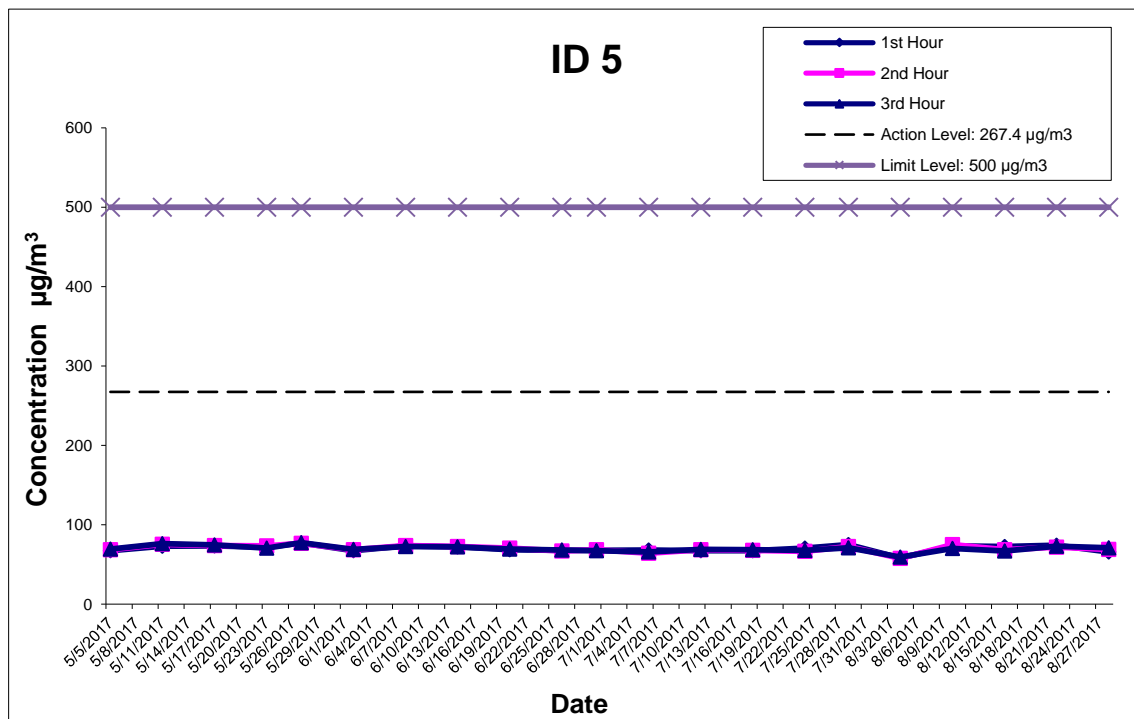
SCALE	N.T.S.	DATE	Sep-17
CHECK	FYW	DRAWN	CCWT
JOB NO.	60043155	APPENDIX No. D	Rev. -

**Graphical Presentations of Impact 1-hour TSP  
Monitoring Results**

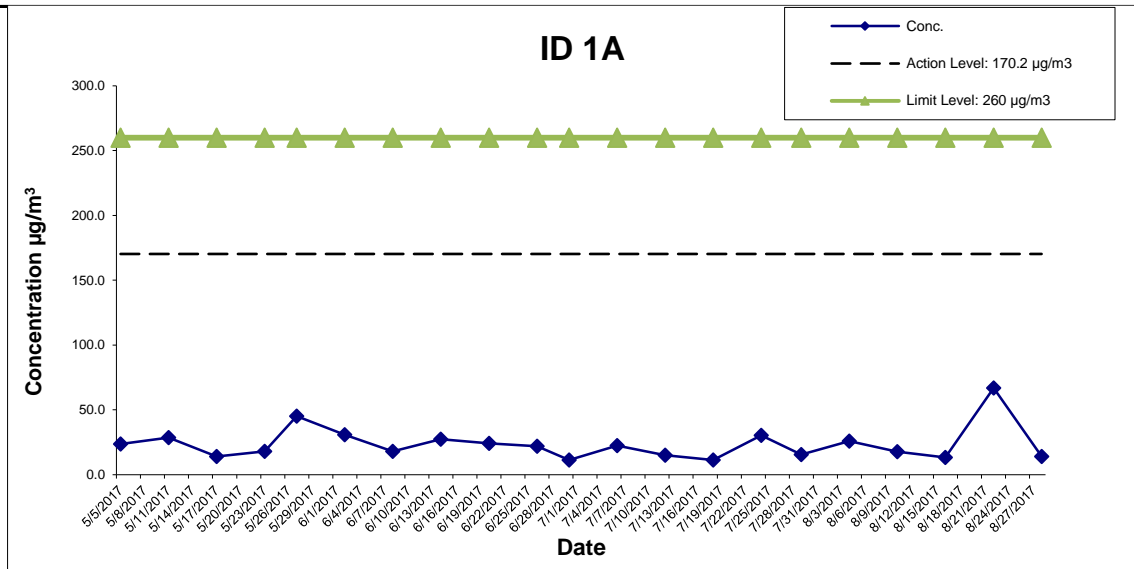
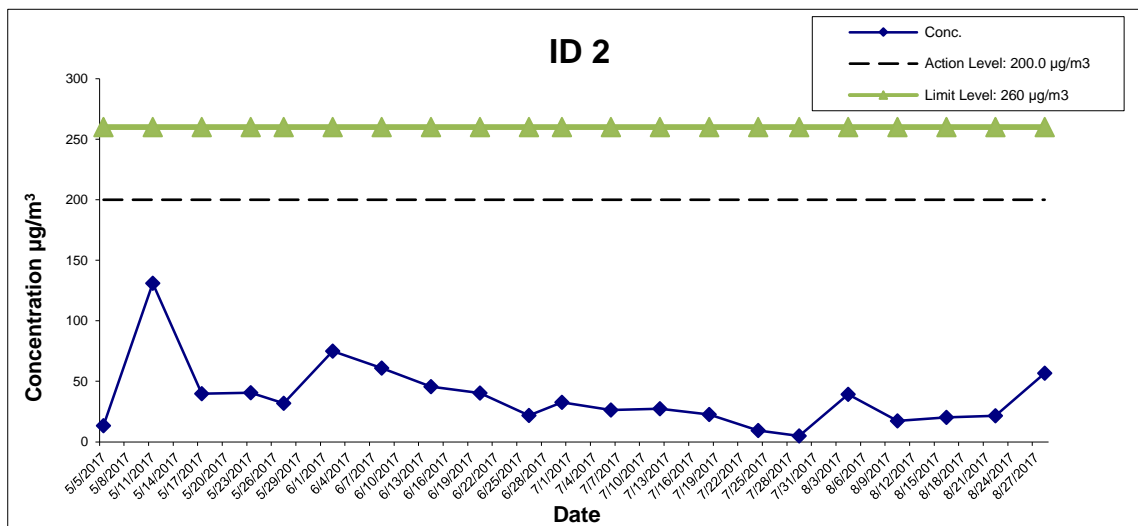
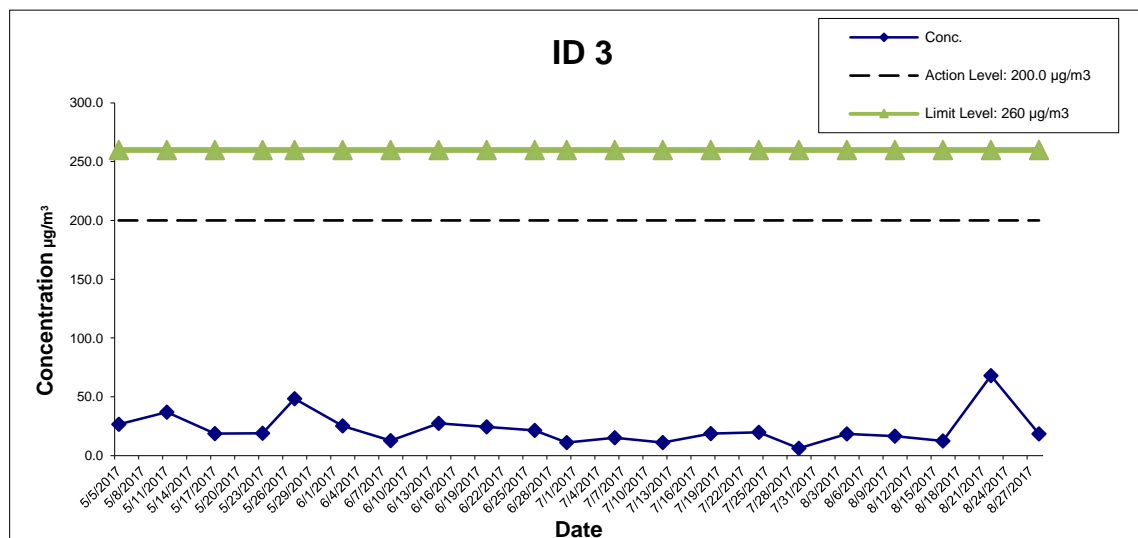
SCALE	N.T.S.	DATE	Sep-17
CHECK	FYW	DRAWN	CCWT
JOB NO.	60043155	APPENDIX No.	Rev.
		D	-

**Graphical Presentations of Impact 24-hour TSP  
Monitoring Results**

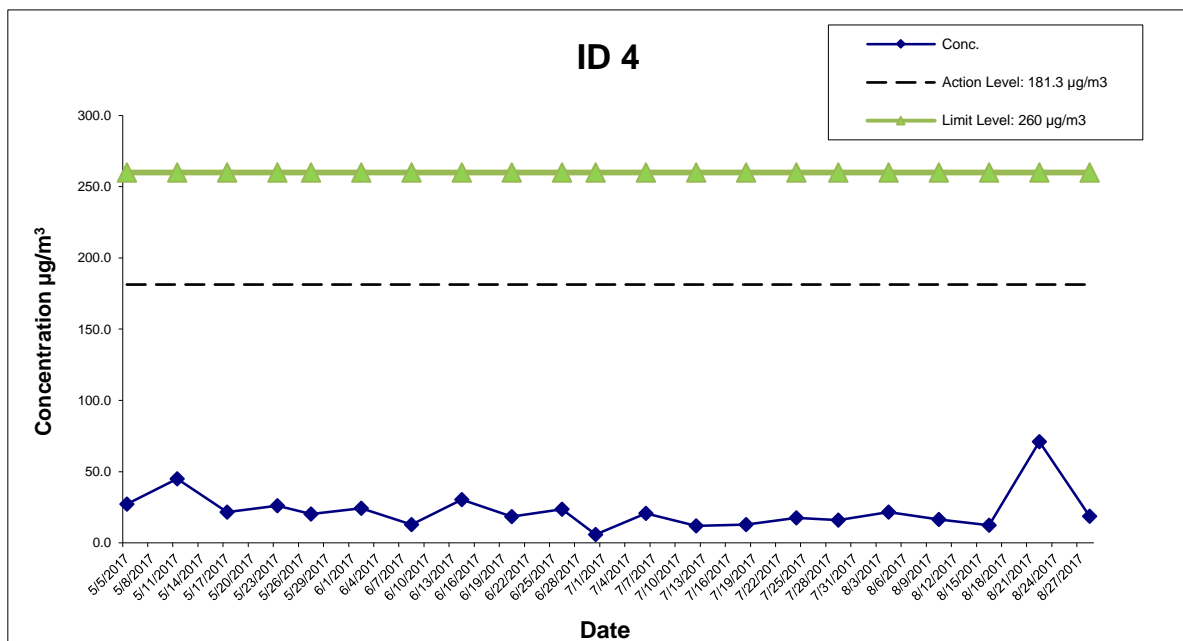
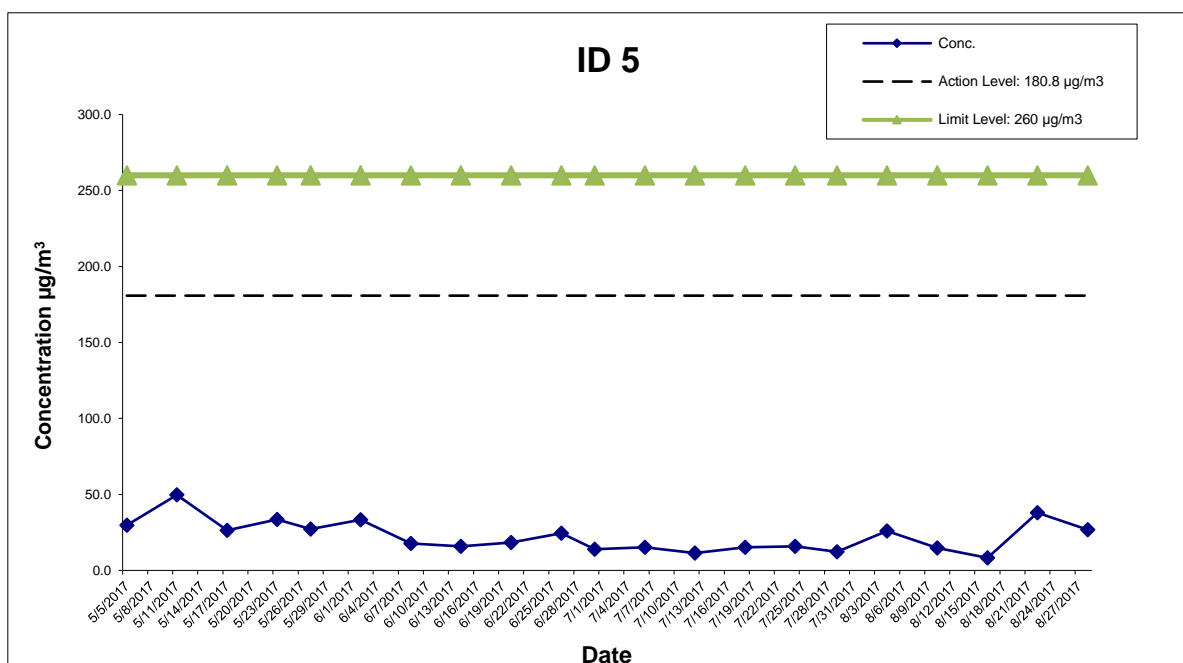
**Graphical Presentations of Impact 24-hour TSP  
Monitoring Results**

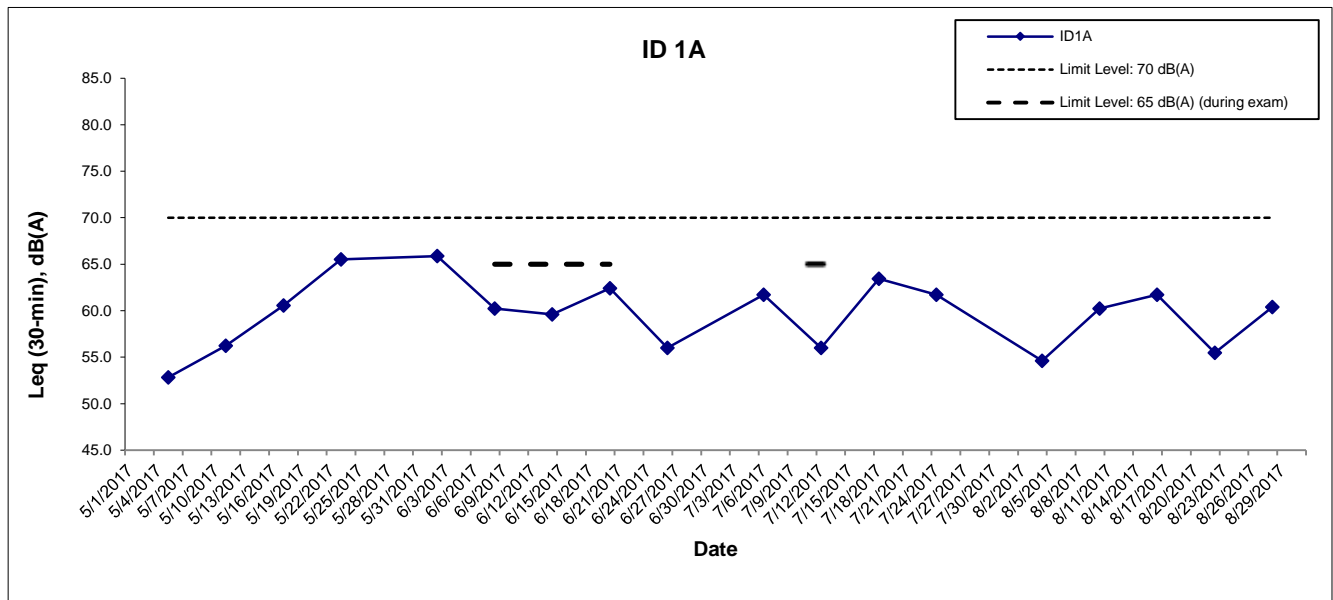
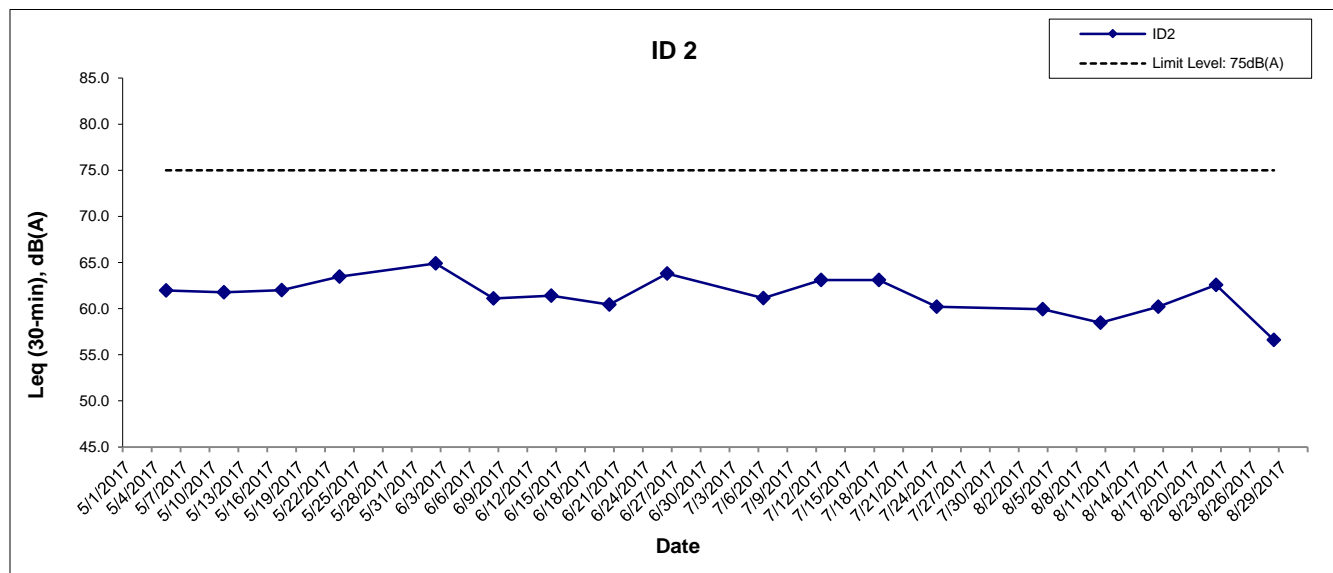
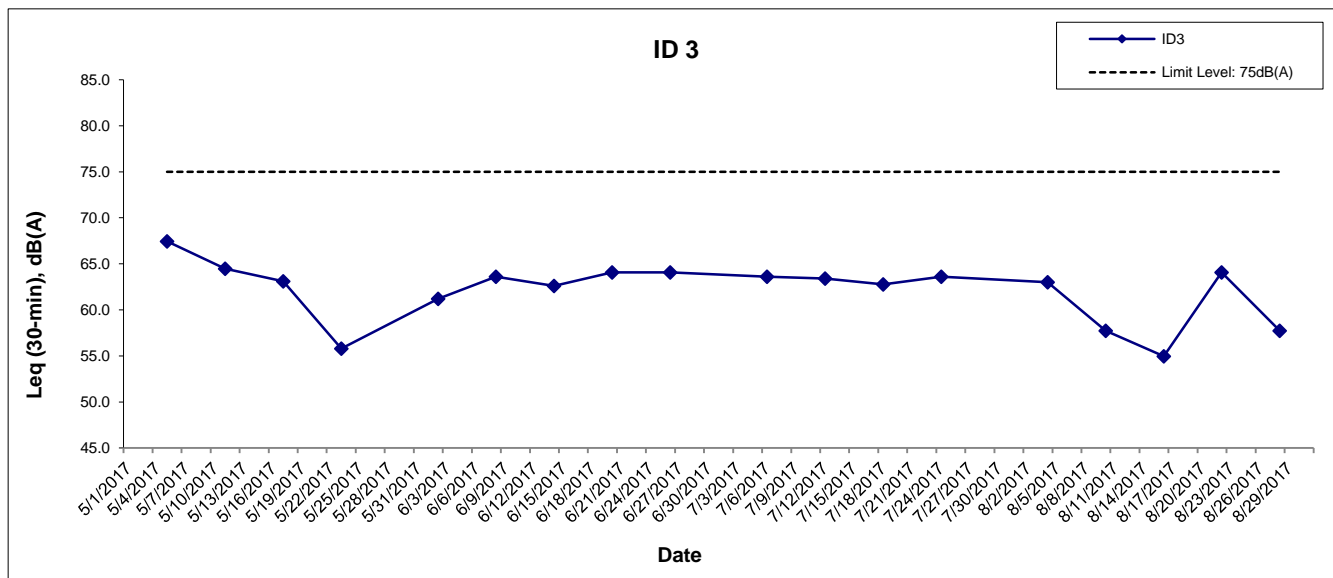
- 3.2.4 No Limit Level exceedance of noise was recorded in the reporting quarter.
- 3.2.5 The graphical plots of trends of the noise monitoring results in the reporting quarter are provided in Appendix E. Major noise source included construction activities of the Project, concurrent construction activities of another project carried out in the vicinity, nearby traffic emissions and noise from school activities and community noise.

<b>Development at Anderson Road - Site Formation and Associated Infrastructure Works</b>  <b>Graphical Presentations of Noise Monitoring Results</b>	SCALE	N.T.S.	DATE	Sep-17
		CHECK	FYW	DRAWN	CCWT
		JOB NO.	60043155	APPENDIX E	Rev -

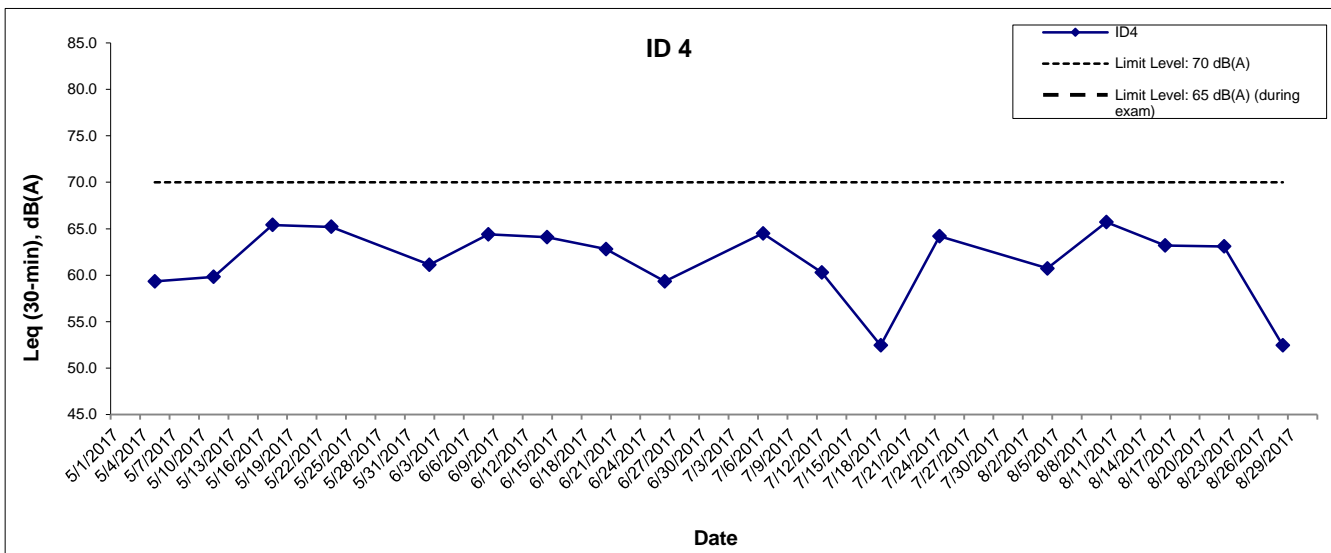
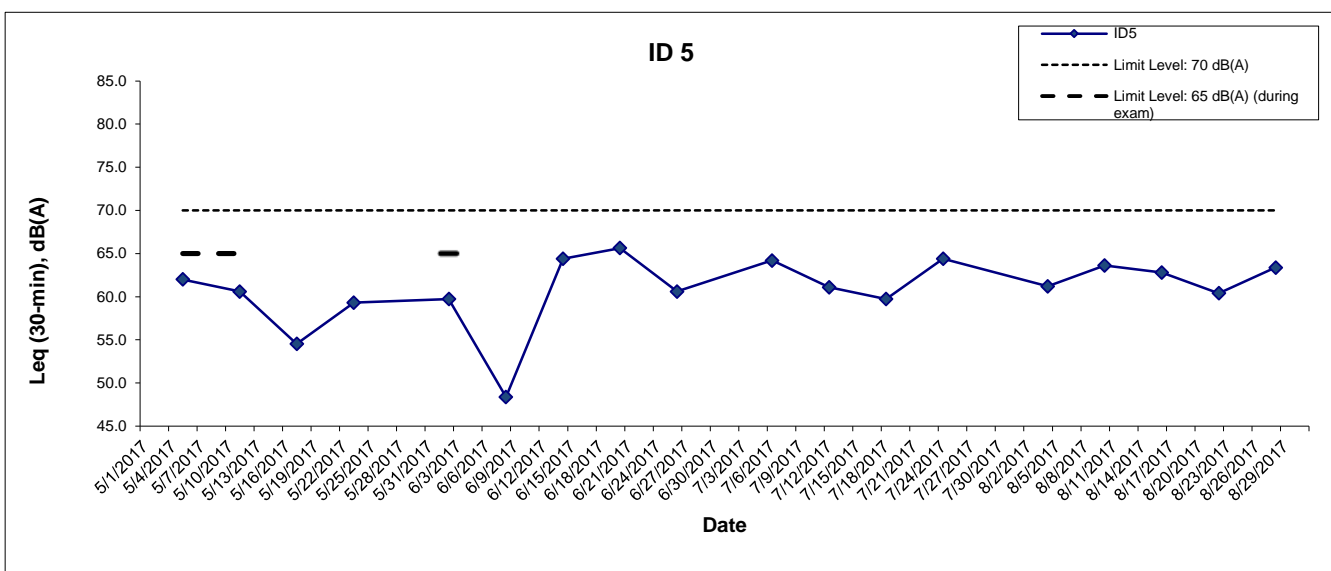
<b>Development at Anderson Road - Site Formation and Associated Infrastructure Works</b>  <b>Graphical Presentations of Noise Monitoring Results</b>	SCALE	N.T.S.	DATE	Sep-17
		CHECK	FYW	DRAWN	CCWT
		JOB NO.	60043155	APPENDIX E	Rev -
