Contract No. CV/2007/03

Development at Anderson Road – Site Formation and Associated Infrastructure Works

Quarterly EM&A Summary Report for June to August 2015

September 2015

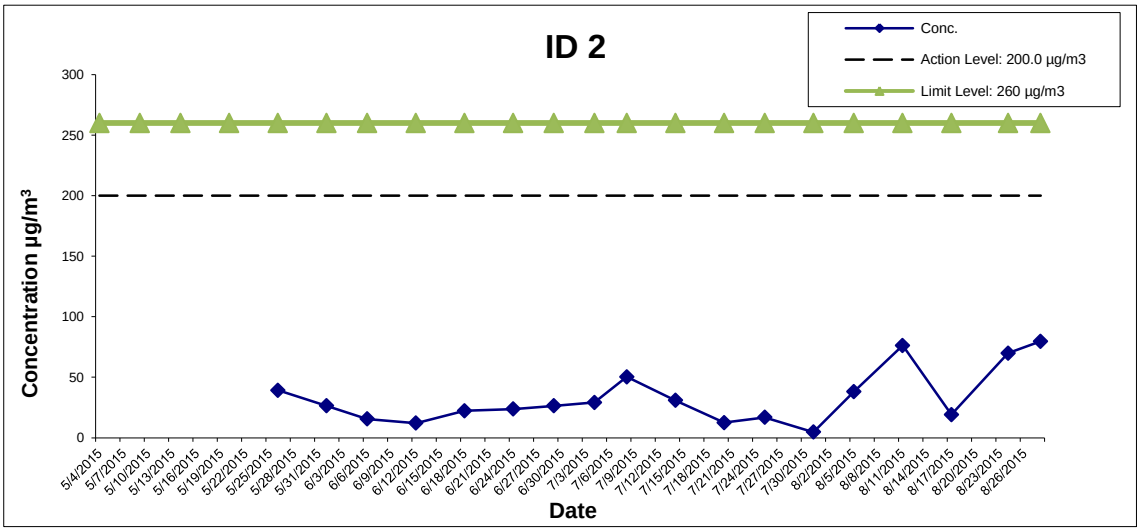
Remark: Due to the failure of electricity supply on the rooftop of ID2 from 4 - 25 May 2015, the 24-hour TSP Monitoring was suspended until 25 May 2015.
